Capital Improvements

21 Governors Court
Baltimore, MD

\$250,000 Building Renovation
Winter 2012-2013

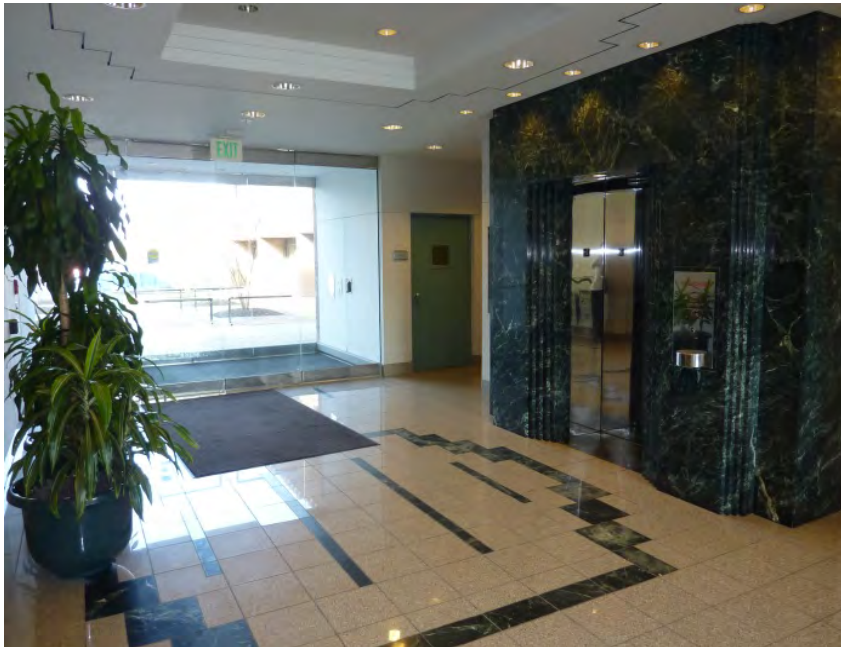
FIRST FLOOR LOBBY – VIEW 1

Granite wall panel & green/white tiled floor, circa early '80s

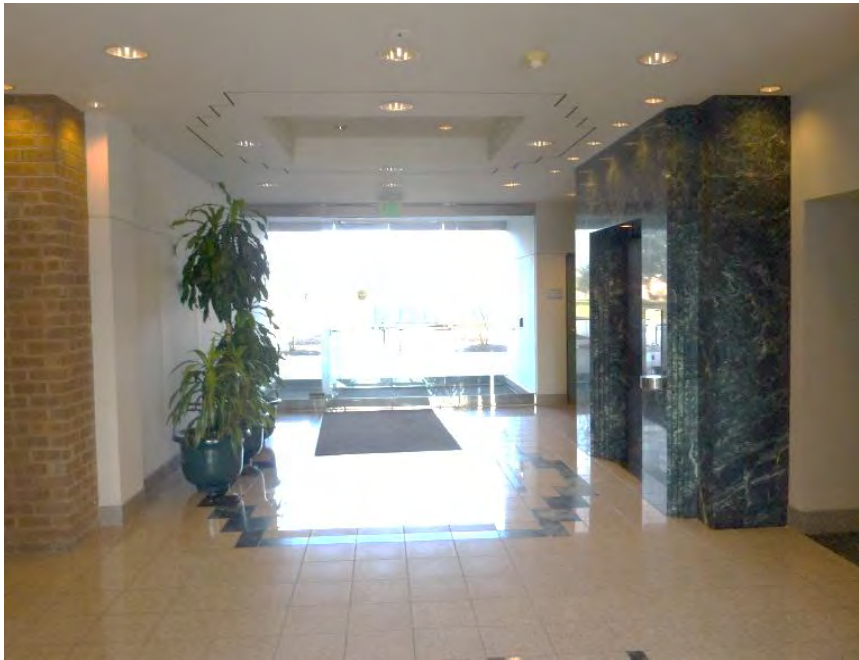
FIRST FLOOR LOBBY – VIEW 2

Exposed (original) brick wall and planters

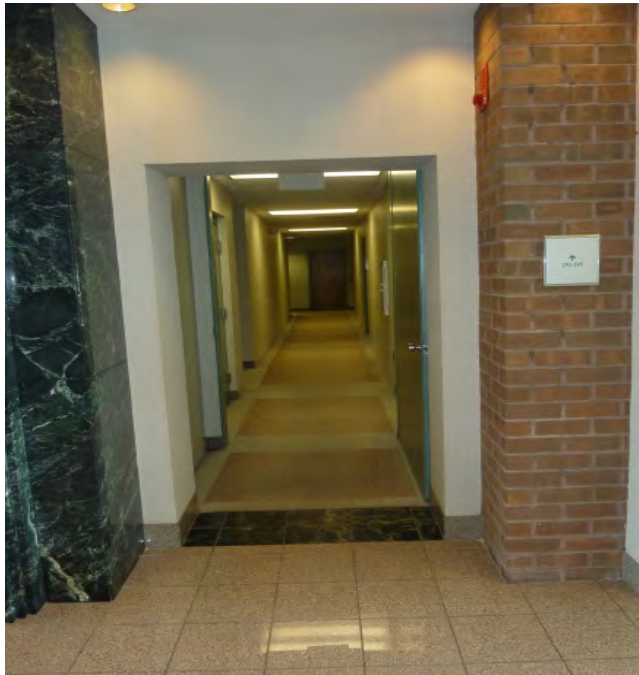
FIRST FLOOR CORRIDOR – VIEW 3

Prismatic light fixtures, standard 2x4 fissure edge ceiling tiles, outdated carpet and wall coverings

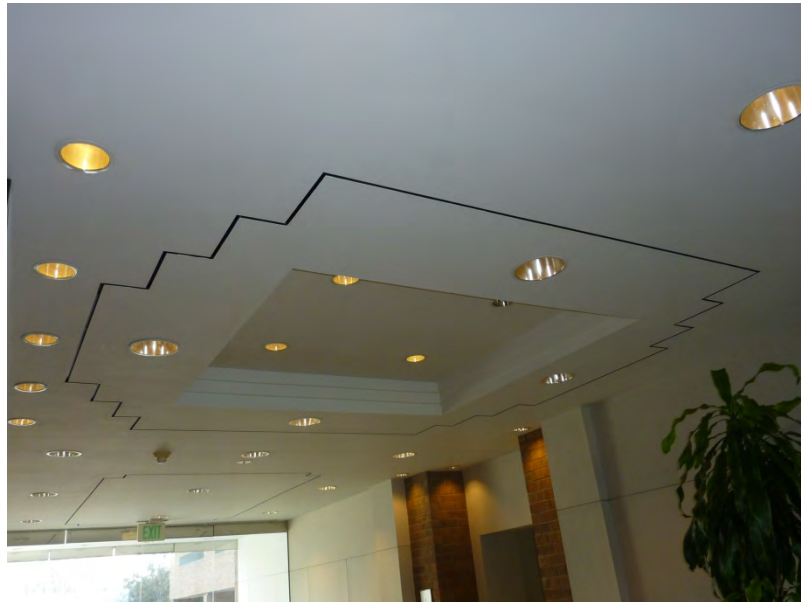
FIRST FLOOR LOBBY – CEILING

Outdated ceiling design consisted of reveals & excessive recessed lighting

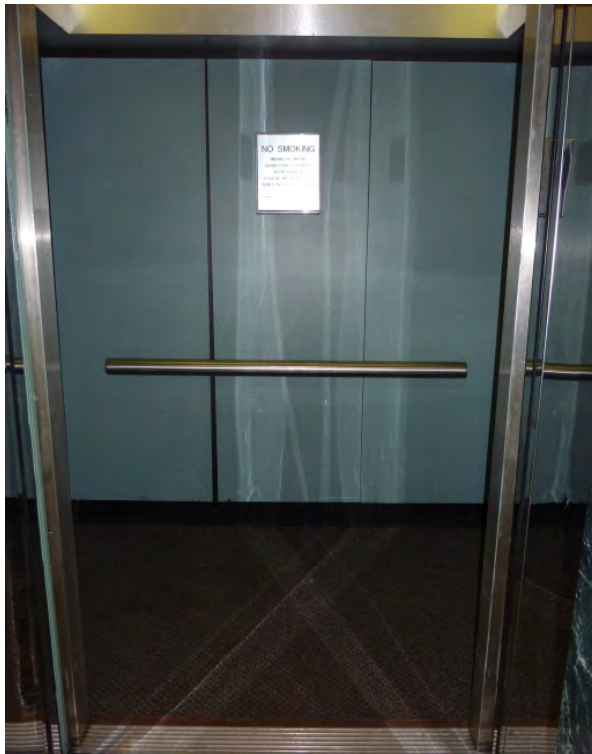
ELEVATOR CAB

Original wall panels, inadequate
outcove ceiling lights & dated
flooring

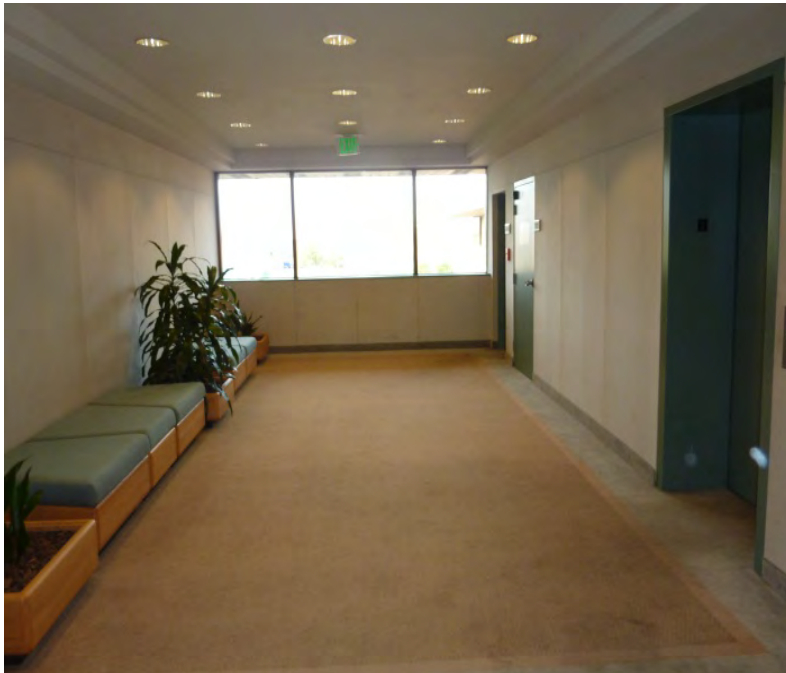
SECOND FLOOR LOBBY -VIEW 1

Outdated furniture, carpet & wall coverings, circa early '80s

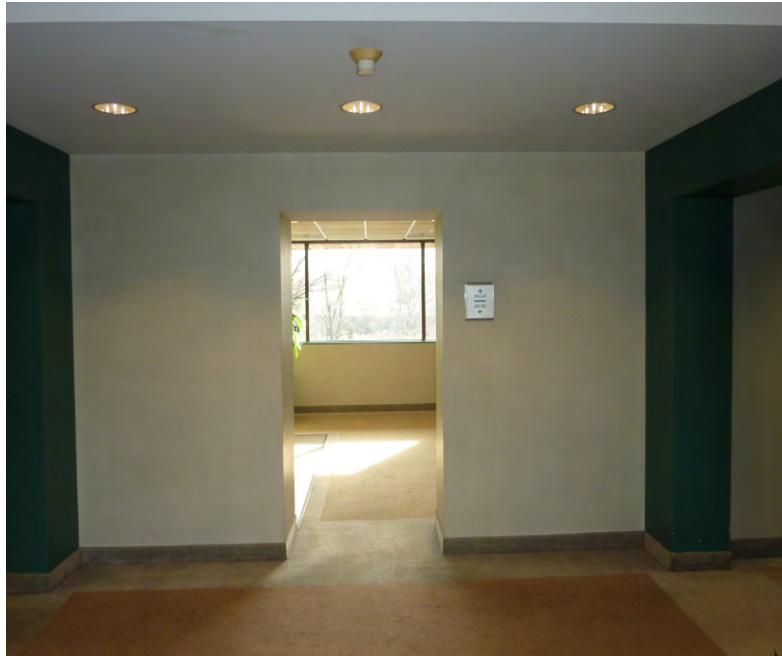
SECOND FLOOR LOBBY – VIEW 2

Single cased opening leading to dead space – complete lack of welcoming environment

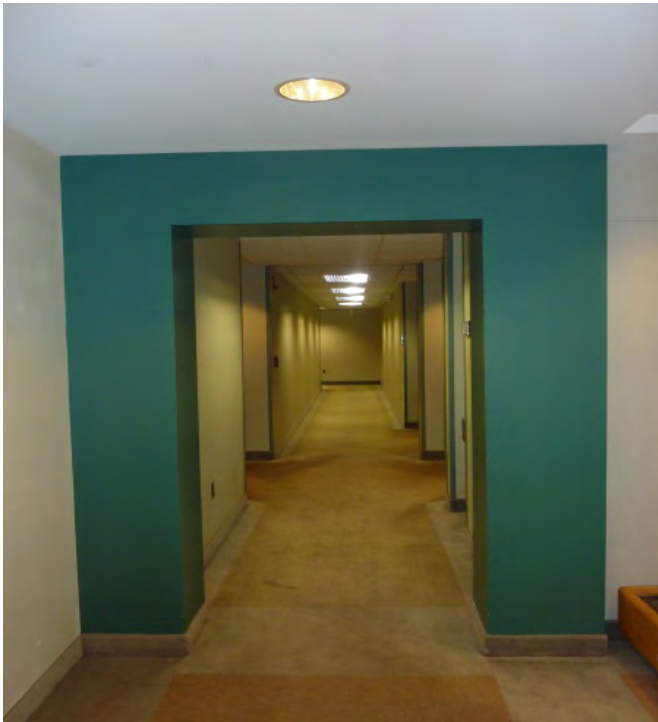
SECOND FLOOR CORRIDOR – VIEW 3

Prismatic light fixtures, standard 2x4 fissure edge ceiling tiles, outdated carpet and wall coverings

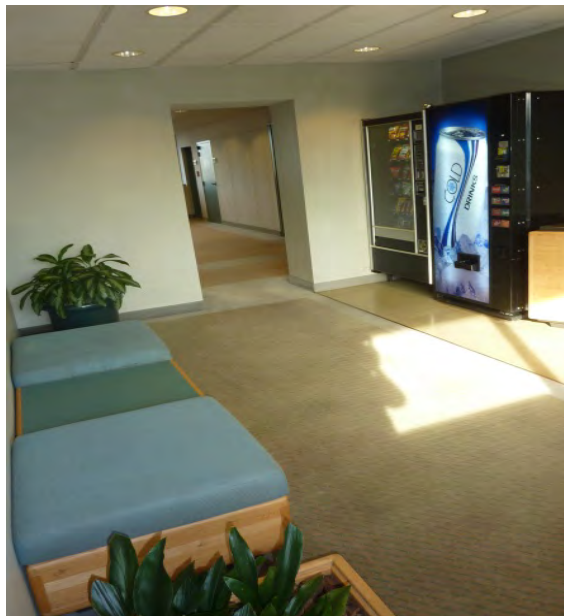
VENDING CAFE

Dead space adjacent to 2nd floor elevator lobby with outdated furniture and vending machines

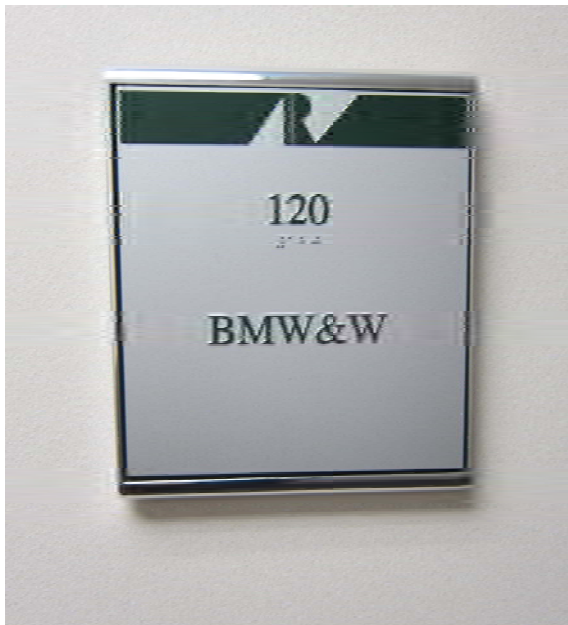
SUITE SIGNAGE & PORTFOLIO BRANDING

Outdated, plain suite signs

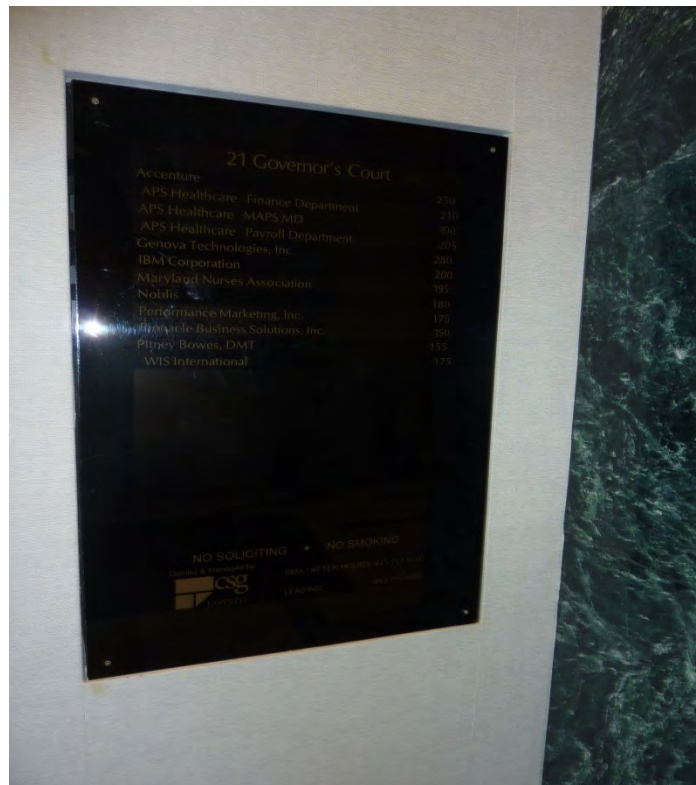
BUILDING DIRECTORY

Very dark, acrylic tenant directory

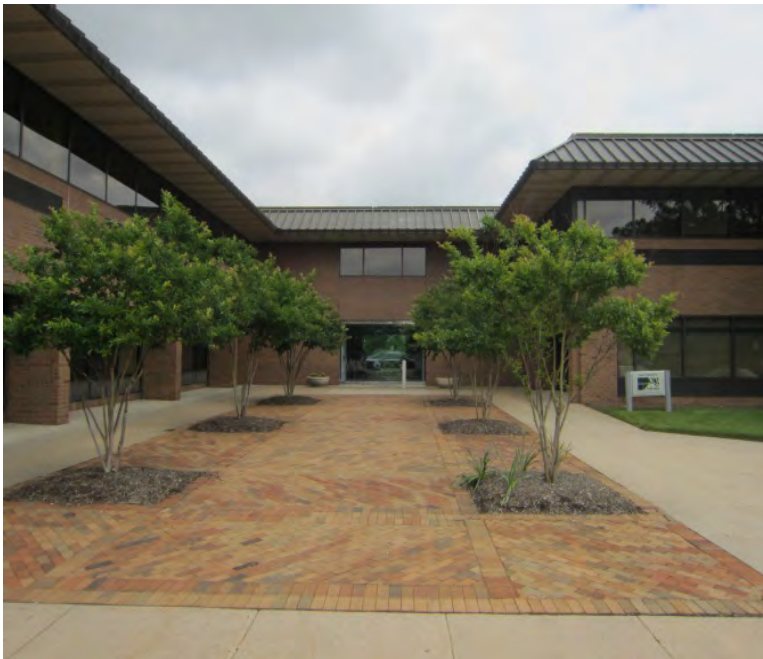
COURTYARD

Six separate tree plots

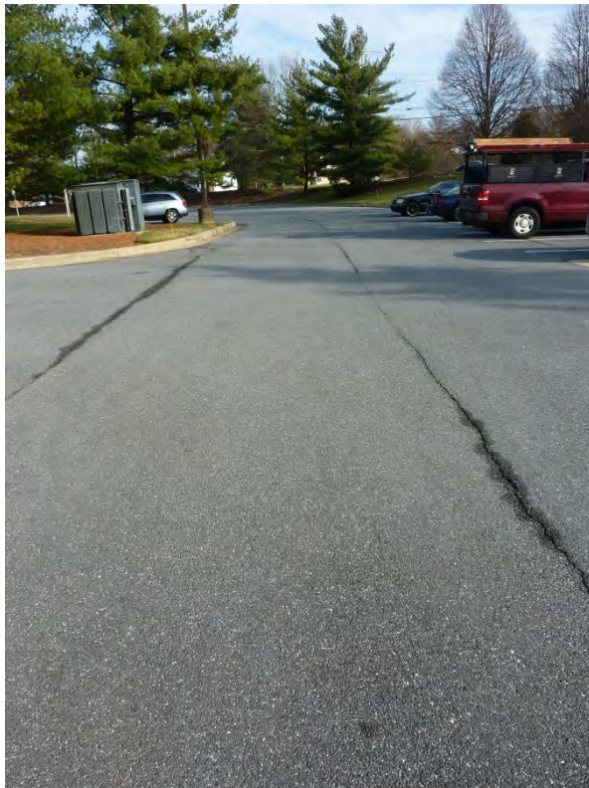
PARKING LOT RESURFACING

Asphalt cracking & alligatoring throughout
